Pool and Bench Vegetation of Goodamon Creek (previously known as Stream E), Ginninderry Conservation Corridor: Spring 2022

Chen-Yang Tsai

Feb 2023

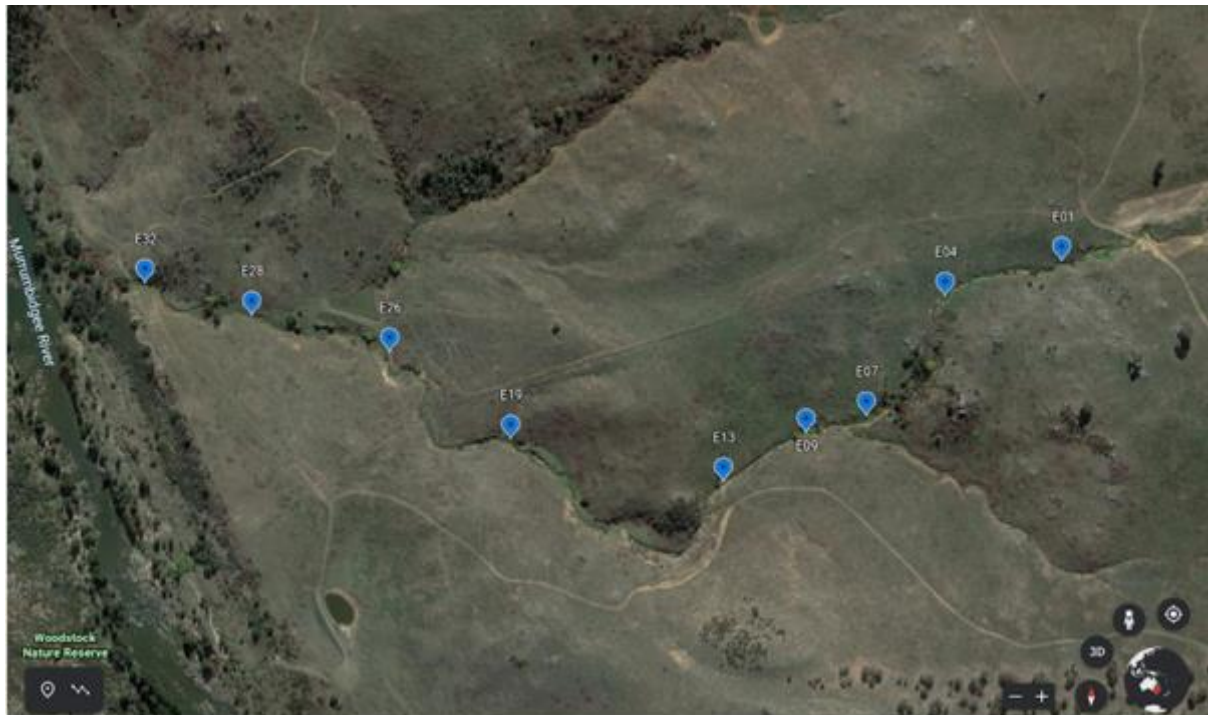
Figure 1. The nine study sites along Goodamon Creek (marked in blue).

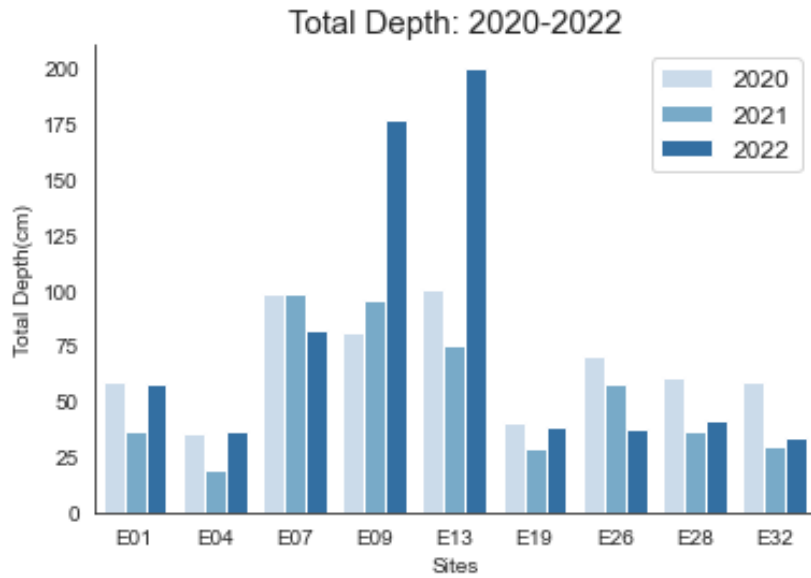
Total Depth (pools): The average of total depth of the pools was measured at 78.2 cm (SD = 64.5). This represents an increase compared to the previous two years that the depths were 53.1 cm (SD = 30.0) in 2021 and 67.1 cm (SD = 22.7) in 2020 (Figure 3). A high variability in total depth was observed between different sites, with depth ranging from 34.0 cm (E32) to 200 cm (E13) (Figure 3). Similar to the previous years, the deepest pools were found at E07 (82.3 cm), E09 (176.7 cm), and E13 (200 cm) (Figure 3). It should be noted that the depth at E13 was too deep to accurately measure, but it can be estimated to be 200 cm.

Figure 3. Total depth (Pools) along Goodamon Creek in 2020, 2021, and 2022.

Despite the overall rainfall in 2022 being lower than the previous year (Figure 2), the impact of a significant rainfall event on the 4th of August and above average rainfall in October was evident in the depth of many pools along the Corridor, particularly in sites E09 and E13. This suggests that the intensity of short-term precipitation events may play a more crucial role in determining the depth of pools, compared to the total amount of rainfall received.

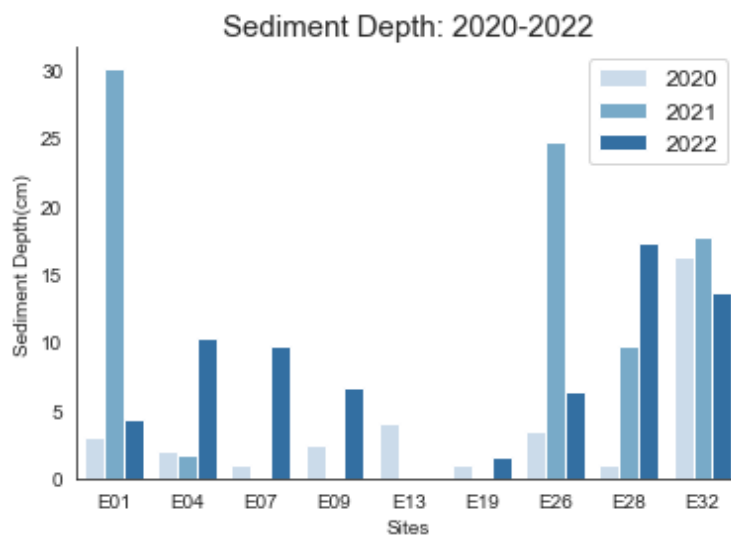
Sediment Depth (pools): The depth of unconsolidated sediment was found to be 8.7 cm in average (SD = 5.1). This represents a decrease compared to the last year that the depth was measured at 10.5 cm (SD = 12.2), but an increase compared to the survey in 2020, which recorded a depth of 3.8 cm (SD = 4.8) (Figure 4). The data revealed that some sites, such as E13 and E19, had sediment depths that were barely visible (less than 4 cm). However, there were also indications of an increase in sediment depth in certain sites compared to 2021, such as E04, E07, E09, and E28. The analysis of all history data suggests that the sediment was more likely to accumulate in the most upstream site (E01) and the most downstream sites (E26, E28, and E32) (Figure 4).

Figure 4. Sediment depth (Pools) along Goodamon Creek in 2020, 2021, and 2022

The above average rainfall in 2022 had a noticeable impact on Goodamon Creek, causing erosion and potentially affecting the sediment depth of various sites, particularly upstream areas. Additionally, the construction activity on Macnamara may have contributed to the deeper sediment depth in the upstream area as well. The inflow of water released from a dam (upstream area) into E28 and E32 may also have played an important role. To further analyze the impact of these factors, more comprehensive data collection is necessary.

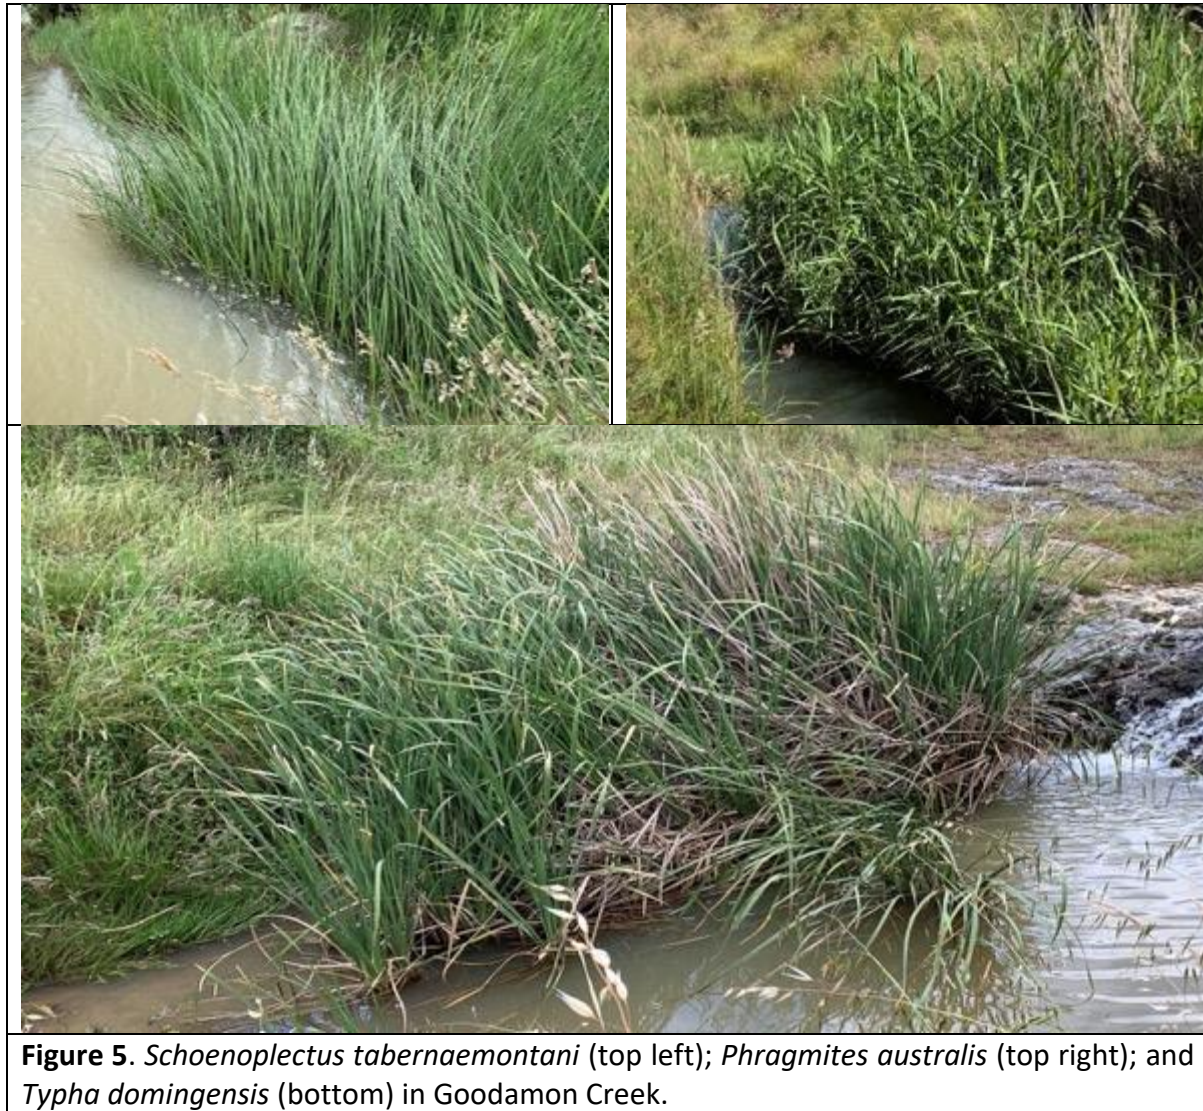
Figure 5. *Schoenoplectus tabernaemontani* (top left); *Phragmites australis* (top right); and *Typha domingensis* (bottom) in Goodamon Creek.

All three species of tall emergent macrophytes were present in Goodamon Creek in the 2022 survey (Figure 5), and no additional species were recorded.

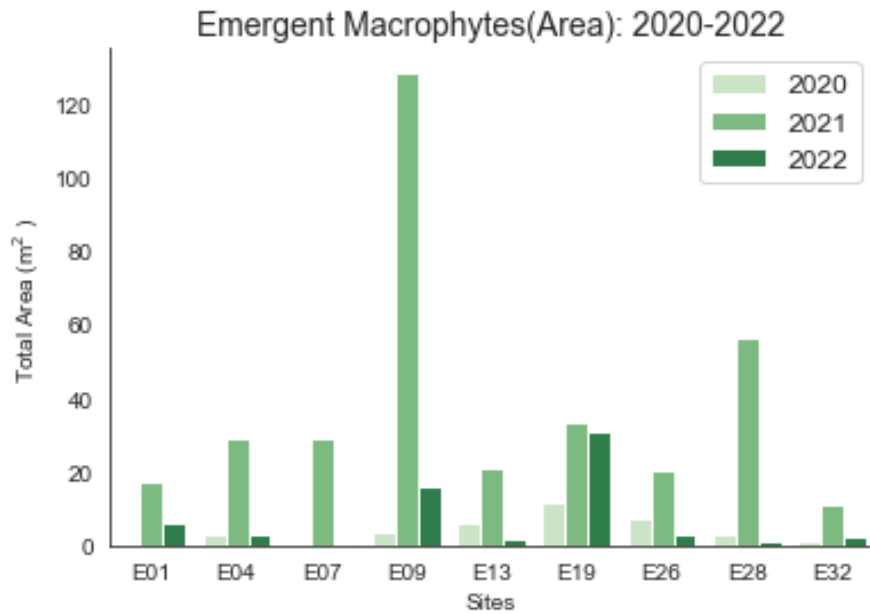
Combined area: The area of tall emergent macrophytes was significantly lower than the previous year. The average area was found to be 7.2 m² (SD = 10) in 2022, which was significantly lower than the 38.4 m² (SD = 36.17) recorded in 2021, but higher than the 3.95 m² (SD = 3.88) recorded in 2020. Like previous years, the area of tall emergent macrophytes varied greatly between sites, ranging from 0.3 m² (E07) to 30.6 m² (E19) (Figure 6). Individually, there were also significant changes in the area of tall emergent macrophytes between these two years; all pools showed decreases compared to the last year. Among them, E09 had the largest decrease, with its area of tall emergent macrophytes decreasing from 128.4 m² in 2021 to 16.3 m² in 2022 (Figure 6).

Figure 6. Area (m²) of emergent macrophytes per pool in 2020, 2021, and 2022

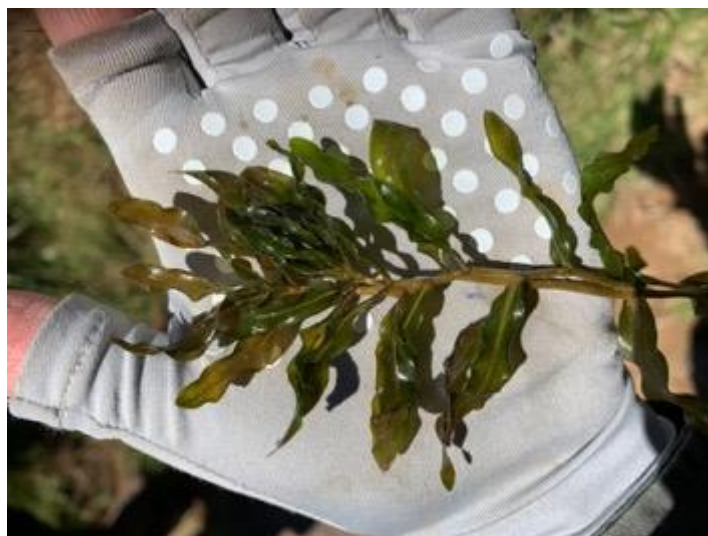
No indicator species of submerged macrophytes was present in Goodamon Creek in 2022, only little individuals (*Potamogeton*) were potentially seen (the population was too small to measure) in E28 (Figure 8).

Figure 8. *Potamogeton crispus* in Goodamon Creek

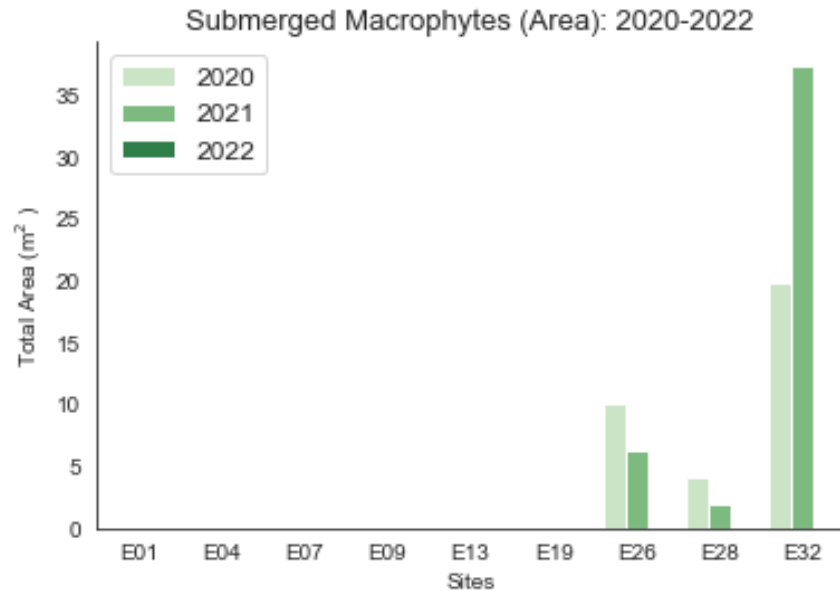
Combined area and occurrence: The area of submerged macrophytes and their occurrence in 2022 can be considered as none (Figure 9) (Table 2). Submerged macrophytes used to inhabit in the most downstream sites (E26, E28, and E32) (Figure 9), but not in 2022's survey. The potential reasons for the absence of submerged macrophytes could be:

Figure 9. Area (m²) of submerged macrophyte per pool in 2020, 2021, and 2022

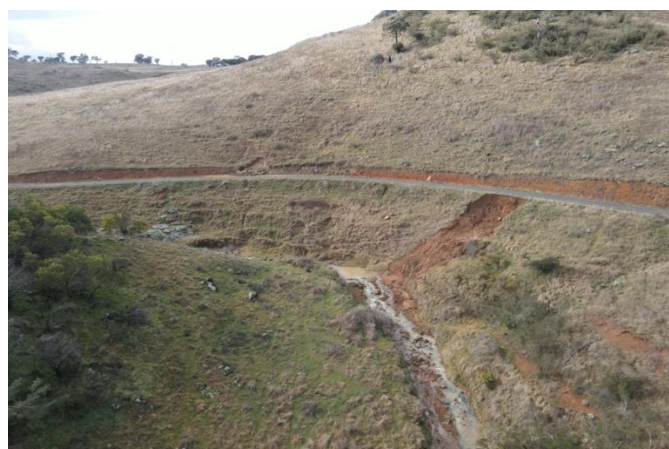
2. The event on the 4th of August 2022 also resulted in major erosion all along Goodamon Creek and resulted in a giant slump that continued to erode the creek (Figure 10).

Figure 10. A giant slump above Goodamon Creek occurred in August 2022 (just below site E13)
